**Tidal Barriers & Opportunities for Salt Marsh
and Tidal River Restoration in
Cumberland County, Nova Scotia**

**By Nicole Hynes, Tony Bowron
and Dawn-Marie Duffy**

April 2005

Coastal Issues Committee Special Publication # 3
Ecology Action Centre

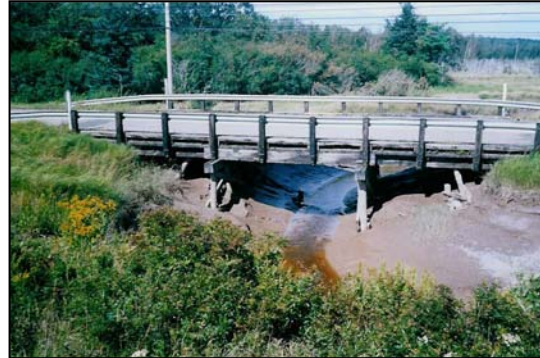
Figure 7. CCCB5B. Bridge seen from the downstream rail road. Salt marsh vegetation is visible on either side of the creek.

Site Description: At this location the downstream crossing is restricting tidal flow and fish passage to the upstream crossing and wetland system. The road crossing (CCCB5B) is an old bridge in disrepair that spans the width of the current river channel. The downstream railway crossing (CCCB6C) consists of two 1m diameter concrete culverts punched through old wooden culverts, placed 1m above the creek bottom. There is a large wetland upstream of the two crossings with remnants of dead trees on the marsh surface, evidence that at one time this system was completely restricted.

Comments: The rail crossing should be replaced with a more appropriately sized and positioned crossing in order to restore a more natural tidal regime and fish passage to the upland system. If this occurs the upstream bridge should be reassessed in light of the increased tidal flow as it may also require replacement by a larger structure and realignment. Pending the replacement of the rail crossing, the current bridge size should be maintained during repairs as it presently does not pose a substantial restriction.

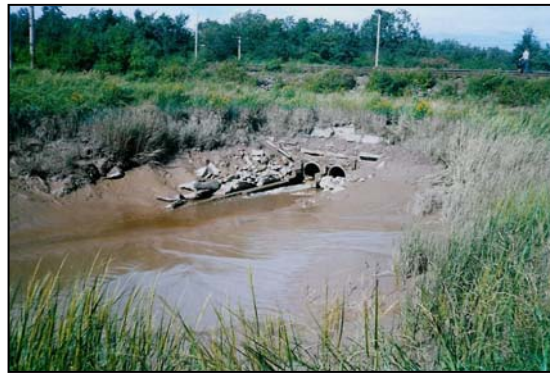
Figure 8. CCCB6C. Downstream of the rail crossing. The new, round, concrete culverts were punched through the old, square, wooden culverts. Photo taken at low tide.

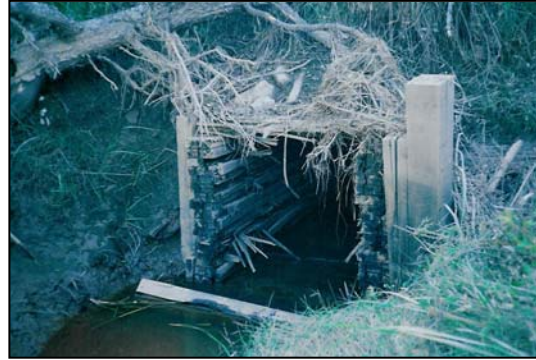
Site Description: This road crossing poses a complete restriction to tidal flow due to a large amount of rock and other material that has collapsed and blocks the downstream end of the crossing. Due to the amount of material blocking the downstream side it was not possible to determine whether the opening of the 1m x 1m culvert was intact and if it was equipped with a tidal gate. The shoulder of the road on the downstream side is eroding and developing small sinkholes, posing a safety risk to traffic and contributing additional sediment and materials to the stream. The upstream end of the crossing is rotting and starting to collapse.

Figure 9. Upstream side of the culvert is damaged and collecting debris.

Comments: This site is in serious need of repair to the road surface and shoulder; this would include removal of material blocking crossing and replacement of the aging and inadequately sized structure.

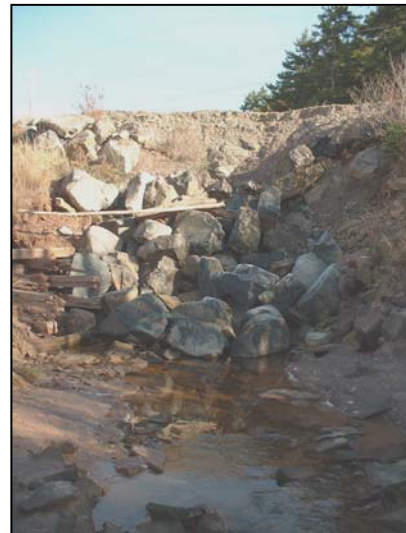
Figure 10. Downstream end of crossing completely buried by rock and other materials. Unclear as to whether a tidal gate is present or not. Damage to shoulder of road surface evident in picture.

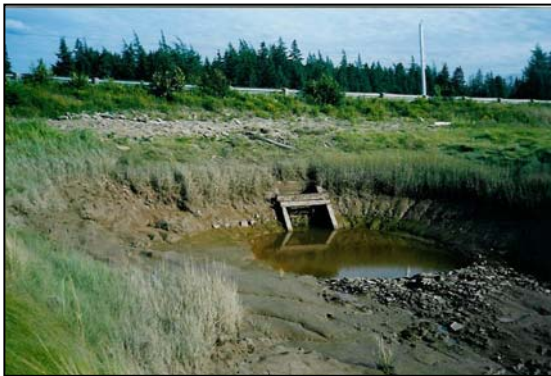
Site Description: This crossing is an intact, functioning, aboiteau. However, due to tidal action the downstream end is prone to clogging by debris (sediment, woody debris and ice). There is active farmland adjacent to this marsh on the downstream side, while the land upstream does not appear to be in use (woodland).

Figure 11. The downstream view of the causeway-aboiteau showing the scour pool and bank erosion.

Comments: There is a substantial amount of tidal wetland habitat that could be restored by initially removing the tide gate and ultimately by installing a larger crossing.

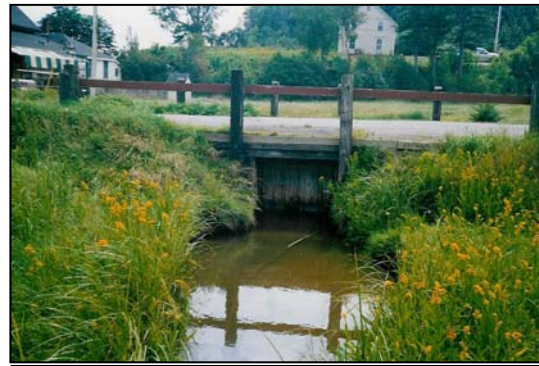
Figure 12. Downstream end of the crossing. The broken gate is visible. It is allowing some tidal flow, but should be removed to eliminate the small amount of pooling.

Site Description: This structure is a small wooden culvert with a tidal gate (aboiteau) which is wedged partially open, limiting upland drainage and allowing for a small amount of tidal flow. The amount of potential tidal marsh upstream is small and adjacent buildings are protected from flooding by the rise in elevation. This channel flows out into the main channel and marsh area near crossing CCMC28B.

Comments: Repair or, more preferably, remove the tide gate from the structure allowing for the unobstructed flow of water through the crossing. While the area of marsh to be restored is small, the work and cost involved should be low and easily conducted as part of regular road maintenance.

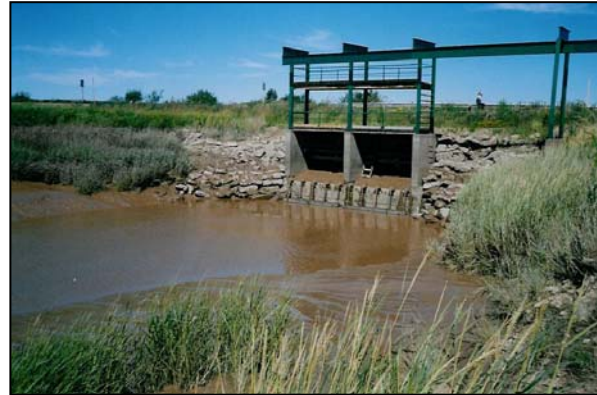
Site Description: Double chambered aboiteau; total opening size 7m; steel gates. Aboiteau is protecting upstream agricultural croplands. No evidence of modification or adaptations for fish passage. Dykes running parallel to the river channel are present both upstream and downstream of the aboiteau.

Figure 13. Downstream view of crossing

Comments: Since the aboiteau is required to protect the upstream agricultural area from flooding, hydrological and tidal marsh restoration may not be an option unless land use patterns change. Fish passage, however, should be addressed.

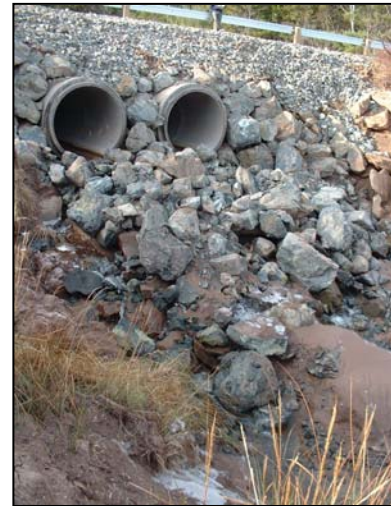
chambered wooden box culvert. Between the August and November site visits, the crossing was replaced by two 1.5m diameter concrete culverts. These culverts have not improved tidal flow or fish passage to the system due to their placement in the roadbed (3m above channel bed) and the placement and collapse of rock and gravel around and in the culverts. Upstream, the stream channel diverges into two separate channels flowing into each culvert. There are also remnants of an old bridge within the channel downstream of the crossing. There is a medium sized wetland system upstream with a mostly wooded riparian zone.

Figure 15. Downstream view of the new culverts.

Comments: Given that this crossing has already undergone replacement, it is unlikely that additional mitigation or replacement work would be considered for this site in the near future. If such work was to be considered for this site, replacement of the culverts with a free-span bridge and reconstruction of the original stream channel under the roadway would be recommended.

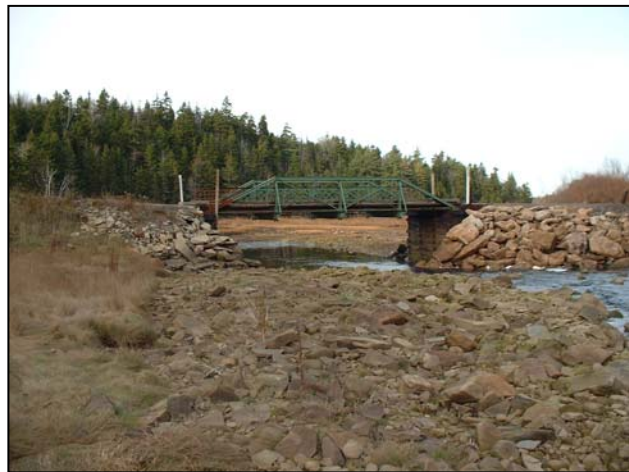
Site Description: The bridge (17m) is causing a slight restriction due to the placement of the support structures and the location of the partial causeway (ratio of channel width to opening size). River is bordered by fringe marsh and the upland is dominated by forest.

Figure 16. Downstream of the bridge clearly showing the build up of the banks with boulders.

Comments: Since this bridge has a large opening the potential for restoration is minimal, however, the channel does appear to be divergent from its original path. Therefore, when replacement is necessary, realignment with the original path should be considered as well

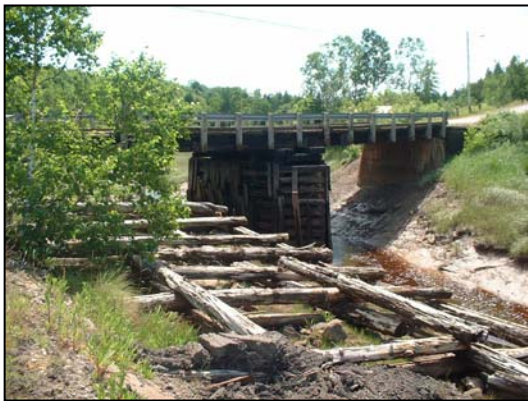
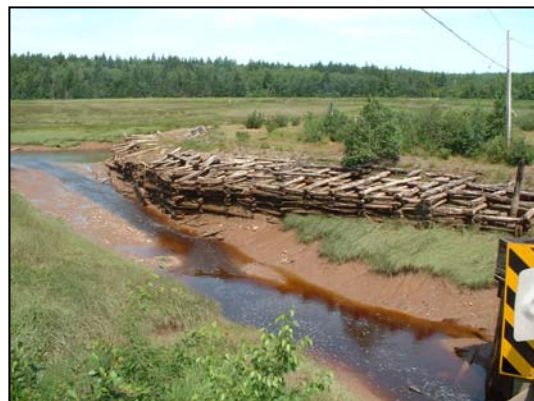
Site Description: This bridge is a wide concrete/wooden structure that appears to be old but still intact. It has a 4m wide support structure in the middle of the river channel causing turbulent water flow around the base and partially restricting natural movement. One side of the river bank is lined with an old wooden structure and there is considerable bank slumping. A large marsh system and a Ducks Unlimited Impoundment are present downstream of the crossing.

Figure 18. Old wooden structure downstream of the bridge, possibly an old wharf. DU bank impoundment off to the right under the bridge.

Comments: While the bridge does span the width of the river, the center support structure which is placed in the middle of the channel does impact hydrology. Removal of this pier should be considered when it is time to repair or replace the bridge. A free-span bridge would be more appropriate for this crossing.

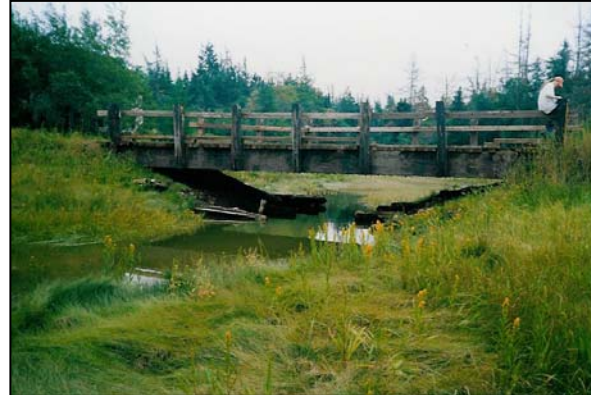
Site Description: The current bridge structure is old and in need of repair, however, it does span the width of the main river channel. It is the remnants of a previous crossing underneath the existing one that are causing a partial restriction to tidal flow, pinching the river. The area around the crossing is a mix of salt marsh and woodland.

Figure 19. Downstream of the crossing. The old structure under the bridge is visible.

Comments: Remove the old structure and maintain the size of the bridge when making repairs.

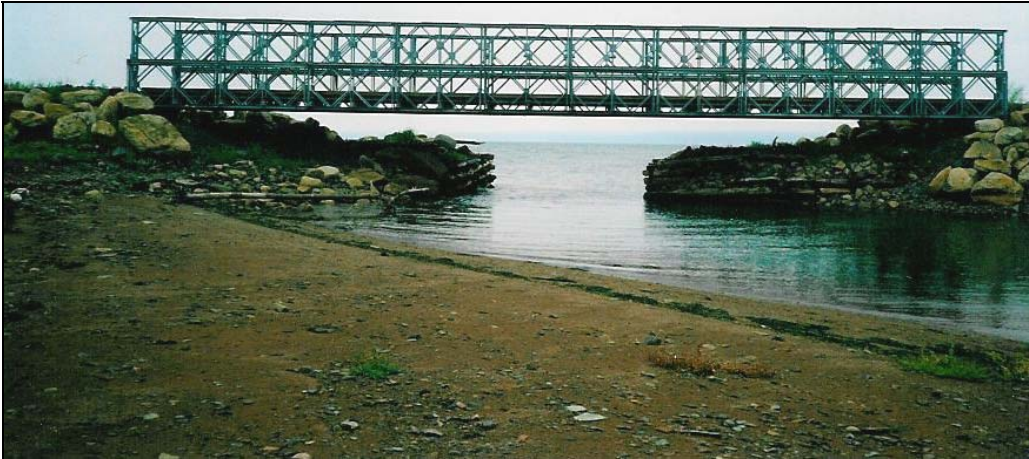
Site Description: The bridge is a large structure that spans the width of the river; however, the banks at the base of the bridge on both sides are pinching the channel. The banks are built up with boulders and wooden cribwork, most likely the remains of a previous crossing at the same location. There does appear to be adequate flow getting through, however, turbulence of the flow is increased due to the restriction (pinching) caused by the remains of the old crossing (turbulent flow and scour pools).

Figure 21. The bridge from the upstream beach (low tide) clearly showing the pinching of the river by the bank support structures.

Comments: Remove remains of the old crossing and excavate the banks to enlarge the opening under the existing bridge to match the width of the main river channel.

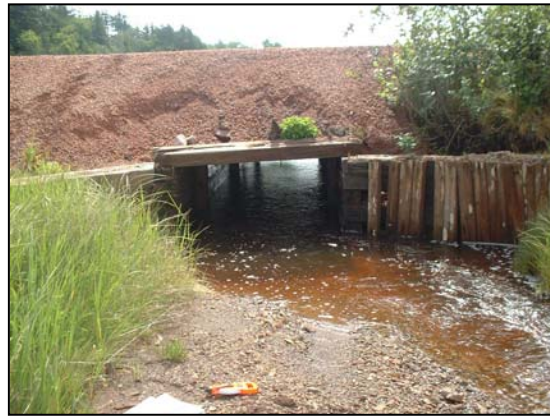
Figure 23. Upstream view of the culvert showing that the culvert is placed slightly off to one side with some pooling and slack water occurring to the sides of the culvert.

Site Description: 2.5m x 1.3m wooden culvert in good condition located upstream from site CCMC28B. Culvert is partially restricting flow as evidenced by scour pools, bank slumping and swirling water forming downstream of the crossing. Wooden armoring of the bank on the upstream end is damaged. There is tidal marsh habitat on both sides of the crossing, grading into a freshwater marsh further upstream.

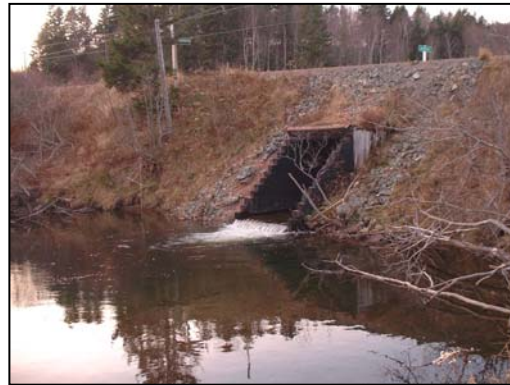
Site Description: Large hanging wooden culvert 2m x 3m in good condition. There was evidence of a beaver dam that has since been removed on the downstream side of culvert. This crossing is likely at or very near the tidal extreme and may experience tidal flow only during larger tidal events. The land around the crossing is wooded and has little opportunity for wetland habitat restoration.

Figure 24. Downstream of crossing. The large pool in front of the culvert is visible as well as the high placement of the culvert.

Comments: Lower culvert in order to be flush with creek bottom. Removal of large woody debris from both the upstream and downstream channel would improve hydrology. Concern at this site is mainly fish passage and stream habitat.

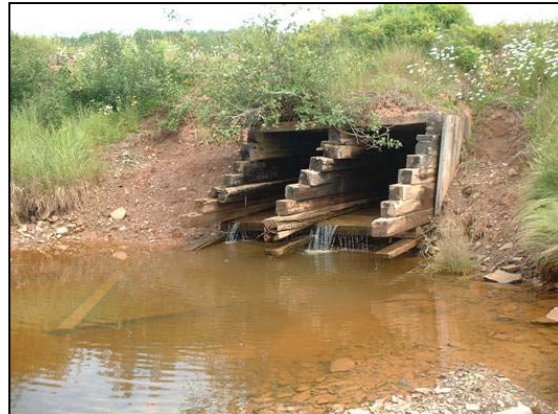
Figure 25. Downstream view of the culvert that has not been placed flush to the creek bottom.

Site description: Aging double chambered wooden culvert (3m x 1.5m) showing considerable disrepair (rotting wood & buckling), that is placed too high from the creek bottom on the downstream end, creating a partial restriction. There is a wetland, dune and beach system downstream of the crossing.

Comments: Replace structure with an open bottom crossing or install new structure even

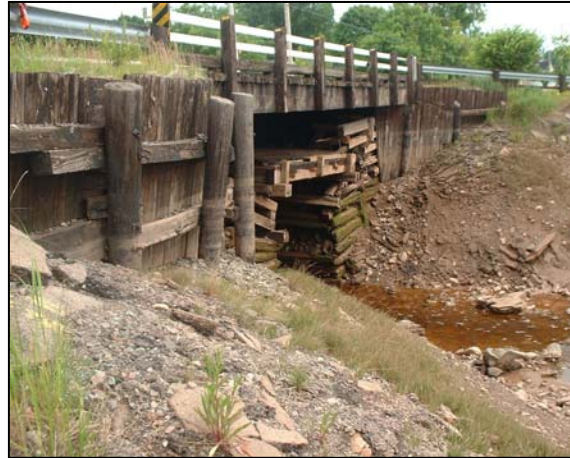
Site description: Current bridge was built directly over the remains of the previous crossing which is in considerable disrepair. New bridge spans the width of the river, however, the old bridge is partially restricting flow by having its support structures in the channel. Land use both upstream and downstream is low-level residential housing built at an elevation beyond the reach of the river. A ribbon of tidal wetland habitat borders the river both up and downstream of the crossing.

Figure 26. Downstream view of the bridge with the old structure visible under bridge.

Comments: Remove the remains of the previous crossing from the river channel in order to reduce/eliminate the restriction at this location. In its current condition, the crossing does not present an obstacle to fish passage, however, failure/collapse of the old cribwork into the stream channel in the future could present an impediment.

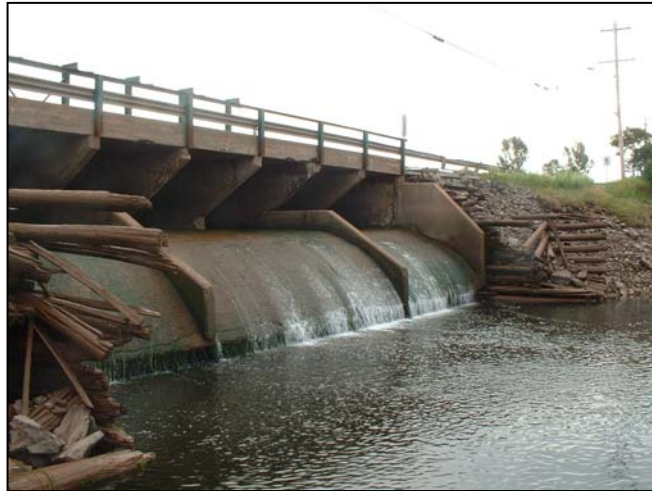
Site Description: Causeway-dam structure with a 21m spillway opening, presenting a complete restriction to tidal flow and fish passage. There is no obvious accommodation

Figure 27. Downstream view of the Parrsborro Causeway-Dam.

Comments: Restoration of tidal flow and fish passage to the upstream system by replacing all or a portion of the causeway-dam with a bridge may not be feasible due to development and current land use activities upstream of the crossing. If fish passage mechanisms are not currently in place, consideration should be given to the installation of such measures.
