## **Assessment of Tidal Restrictions Along Hants County's Highway 215: Opportunities and Recommendations for Salt Marsh Restoration**

by Tony M. Bowron and Allison Fitzpatrick

September 2001

Marine Issues Committee Special Publication Number 9  
Ecology Action Centre  
September 2001

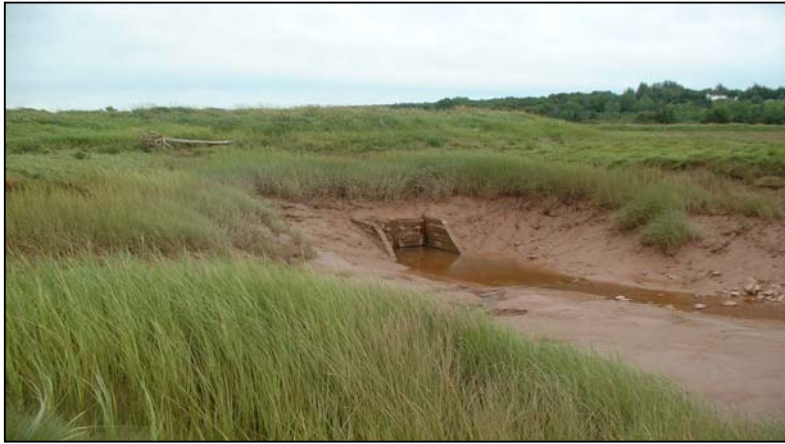
*Left: main tidal channel, dyke and double aboiteau at low tide.*

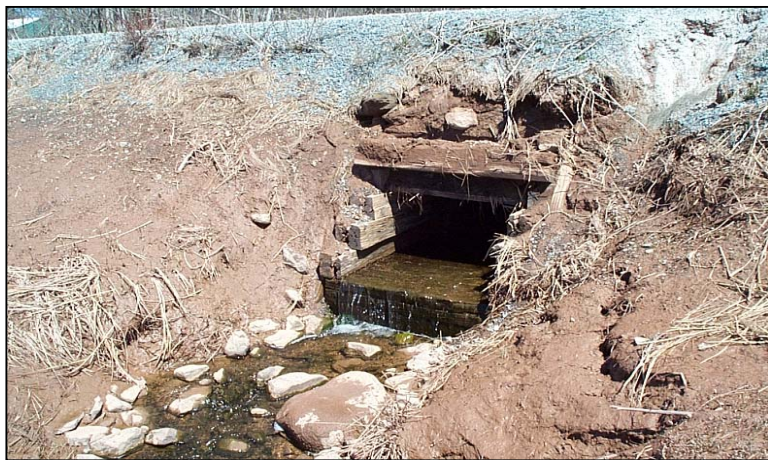
*Right: culvert inlet on the downstream side at low tide. Note the bank slumping and sediment deposition on the marsh surface and in the stream channel.*

Figure 1 provides evidence of a restrictive tidal crossing as the two curves although similar in shape do not lie on top of each other. This occurs because the upstream invert is located above the channel bed, trapping water as the tide drops below the culvert and during low tide, hence a curve that peaks at high tide and is flat for the remainder of the measurements. In addition, the larger tidal range on the downstream end indicates that culvert size is also causing a restriction. This was observed as the tide rose and the culvert became submerged, flooding the downstream channel and surrounding banks.

The installation of a larger, better-positioned culvert would allow for increased tidal inundation and the restoration of an area of 2-3 hectares.

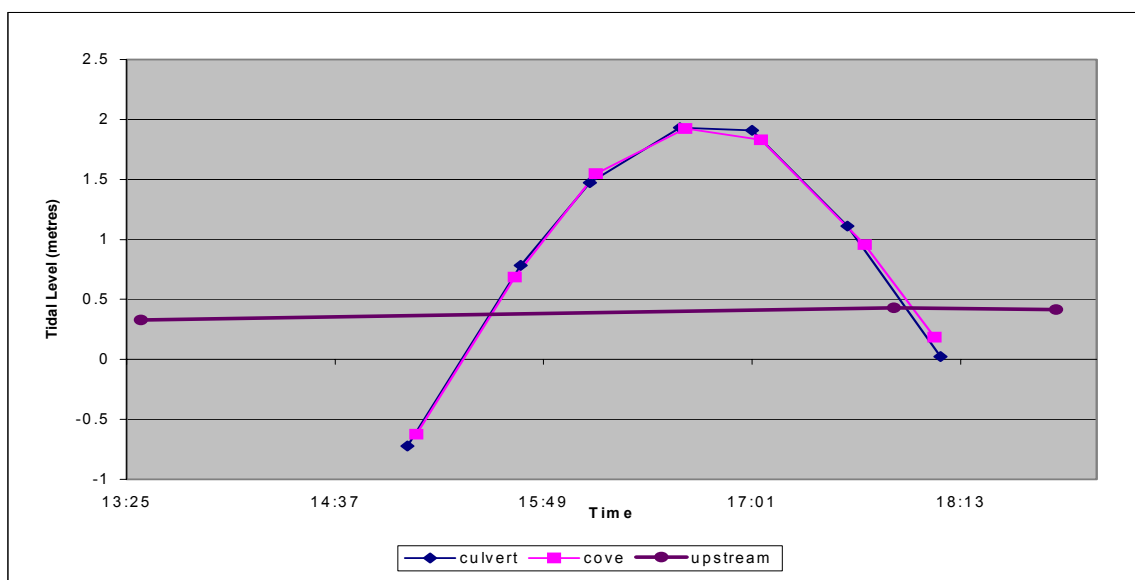
FIGURE 2: TENNECAPE TIDAL ANALYSIS

Previous observation of this crossing during a spring tide event, combined with the lack of evidence on the upstream side of the culvert of saltwater passage, indicated that very little saltwater actually passes through the culvert. Investigation of the culvert on this day, revealed a distinctive debris line from the previous high tide within the culvert. It was assumed that if saltwater did not pass through the culvert on the previous high tide that it was not likely to do so on this occasion.

Measurements were taken at two locations downstream from the road - near the culvert and in the outer cove - and show very little difference in tidal range (table 2), indicating that there are no natural restrictions on the downstream approach to the culvert. Data collected on the upstream side of the culvert at the edge of the river shows a slight increase in water level at high tide. Bubbles at the edge of the road and water flowing from the roadbed indicate that this increase is due to a combination of saltwater moving upstream under the road and freshwater backup. It should be noted and stressed that the increase in water level on the upstream side is not due to flow through the culvert, as this did not occur at any point during the monitoring.

The replacement of the causeway, with the construction of a bridge over the Tinnecape River as was the previous crossing, would be the ideal solution for this location allowing for free non-restrictive movement of water and species at all times.

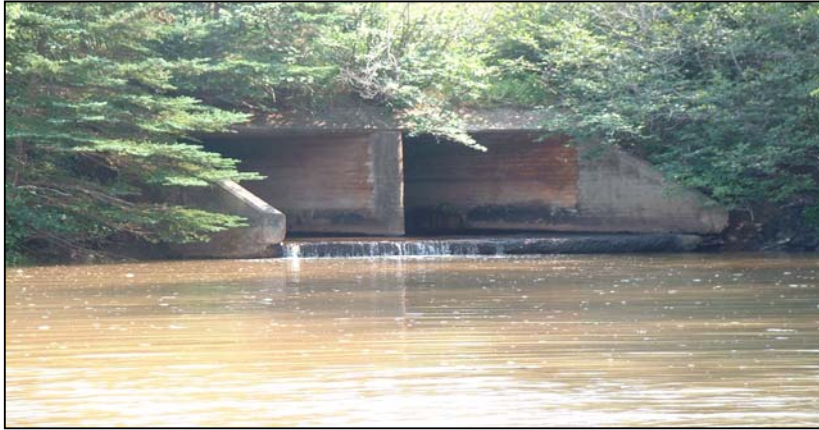
Downstream, the culvert invert is situated two metres above the base of the channel with freshwater flowing constantly through it from upstream. Pooling is occurring at the base of the downstream invert causing erosion of the banks on the downstream approach as well as beneath the culvert. On the approach to the culvert, remnants of a wooden bridge jut into the channel from both of the banks. On the seaward side and to the right of the bridge remnants exists a small salt marsh and channel leading to a corrugated culvert running beneath a small dirt road. This one lane dirt road leads further out in cove where there are Triassic sandstone cliffs containing plant and animal fossils.

*Left: culvert at high tide (3:45pm); water just barely reaches the underside of the base of the culvert. A small amount of freshwater continues to flow out of one side of the culvert.*

Since the area upstream from Highway 215 is essentially completely restricted from saltwater flow due to the culvert location, repositioning of the culvert is necessary to remedy this problem. The culvert is on an angle with respect to the perpendicular to the road, and is situated approximately 2m above the base of the river channel. In addition to cutting off all saltwater flow upstream, pooling is occurring at the base of the culvert, leading to erosion of the banks near and beneath the culvert. The culvert size should be sufficient to allow for adequate flow, so we recommend that it be lowered until it is even with the base of the river and angled correctly with the run of the river.

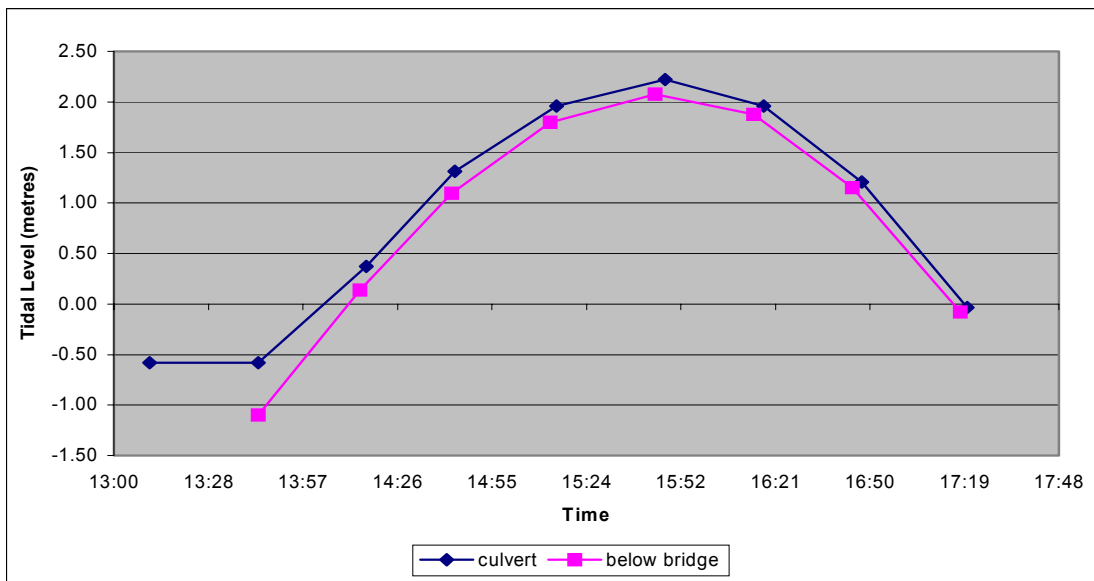
FIGURE 3: RAINY COVE TIDAL ANALYSIS

Upstream measurements were not taken for this site due to the fact that water did not enter the culvert at any point during the spring tide event; and the lack of evidence upstream of saltwater intrusion. The data in table 3 and the plots in figure 3 are of measurements taken at two downstream locations (near the base of the culvert and beyond the old bridge) to check for restriction due to the bridge remnants. Although the tidal range at the culvert is less than that below the bridge structure, this should not be cause for concern because there is no lag time between the two locations, and the differences in tidal levels are quite small.

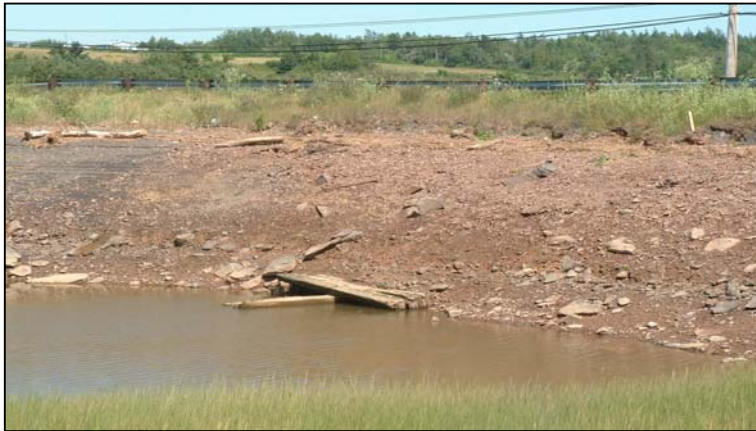
Downstream, water pools at the culvert with a small fringe marsh forming on the sides of the pool. A rocky, barrier beach is forming on the approach to the pool and is subsequently diverting water flowing away from the culvert downstream. Near the culvert, material from the road is sliding and being washed down the bank into the river channel.

*Left: downstream culvert three hours prior to high tide. Debris is present on banks and pooling of freshwater is occurring at the base of the culvert.*

Enlargement of the culvert is necessary to increase tidal flow upstream and to eliminate the lag between the upstream and downstream ends. Placement of the culvert is also of concern as the barrier beach that is forming may eventually cut off all flow to the culvert and cause water to flood the road. We are aware that the causeway is a popular stopping spot for tourists as it faces Cape Blomidon so replacement of the entire causeway with a bridge is not a viable solution. The replacement of the existing culvert with a larger culvert, or even a small bridge, would increase tidal flow significantly, reduce the dangerous currents and would not require replacement of the entire causeway. Removal of the dykes in place, which do not appear to have any agricultural function, would also allow saltwater to flow more fully over the original marsh surface and eliminate the freshwater flooding that currently occurs in the area.

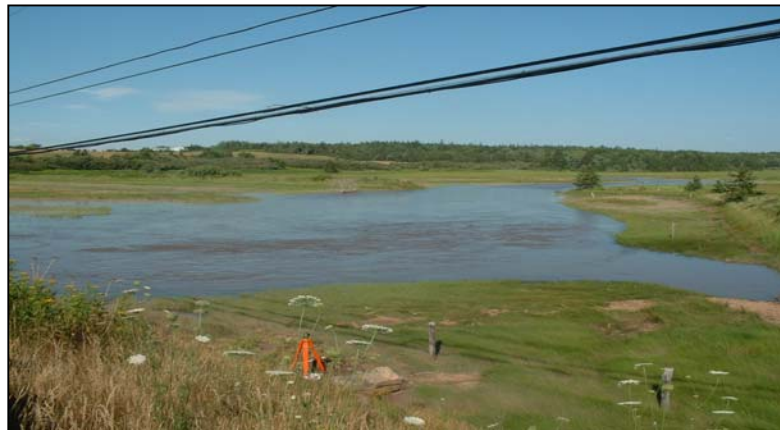
*Right: upstream at high tide (5:25pm); dykes are present on either side of the flooded area. Culvert is situated to the left of the photo and restorable area extends left, right and back beyond the range of the photo.*

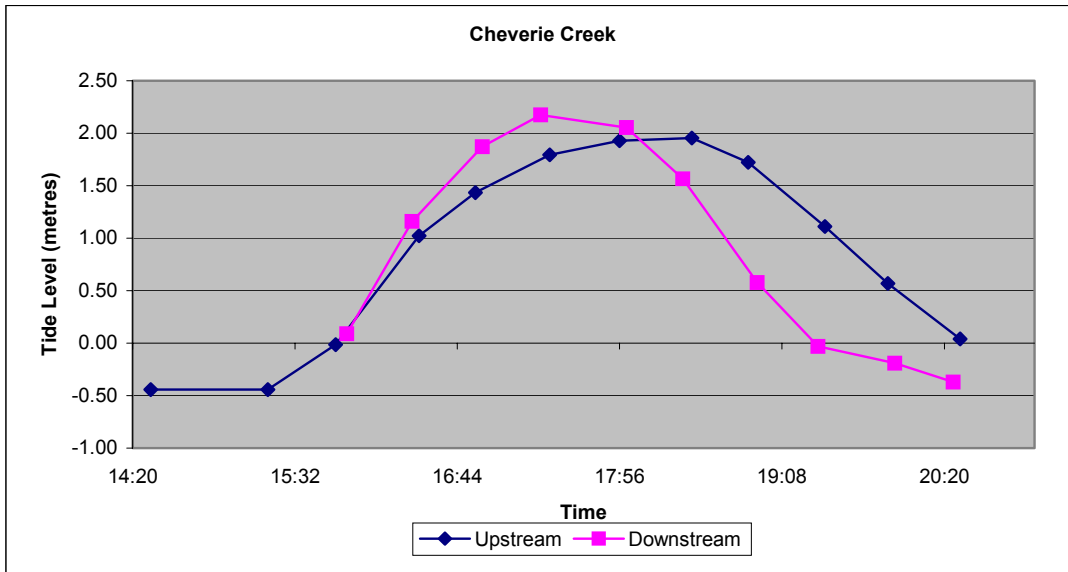
FIGURE 4: CHEVERIE CREEK TIDAL ANALYSIS

Figure 4 indicates that the culvert, although allowing for tidal flow to the upstream side, is insufficient in size and is not providing adequate flow. The difference in time for the upstream and downstream sides to reach peak levels, referred to as lag, and the difference in the tidal levels indicate that the culvert is not sufficient for the location. Both the upstream and downstream culverts were completely submerged an hour and a half prior to high tide leading to dangerous undertows on the downstream side and a large whirlpool at the upstream end of the culvert during the falling tide. After high tide, as the downstream end began to drop, the upstream end continued to rise as water was still being forced upstream through the culvert. Three hours after high tide both the upstream and downstream levels were dropping, however they were not yet at the levels observed three hours prior to high tide.
