Tidal Barriers Audit Summary Report: Lower Bay of Fundy 2004

By Nicole Hynes

April 2005

Coastal Issues Committee Special Publication Number 5

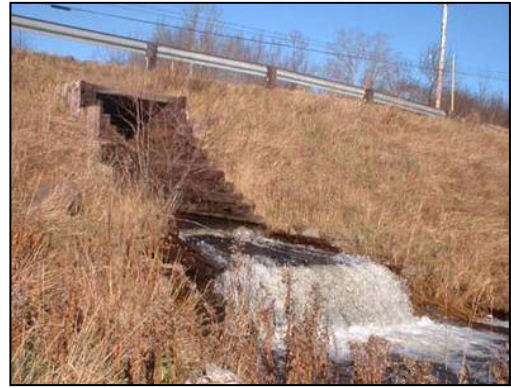
Comments: These crossings are summarized together because of their low restoration potential and similar tidal situations. They are not experiencing much tidal influence due to their placement and because of the rise in elevation just upstream of the crossings. With each crossing the potential for an increase in wetland habitat is low. These culverts were all smaller than the width of the streams, and many are placed too high in the creek bed for adequate fish passage. Site DC6C is the only site with significant salt marsh habitat that could potentially benefit from culvert replacement.

Figure 2. AC1C – Thornes Brook, downstream

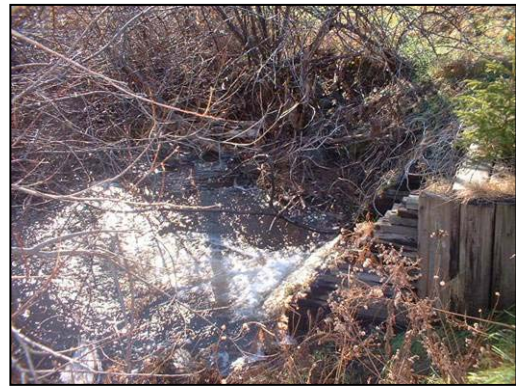
Figure 3. AC2C – Port Royal, downstream

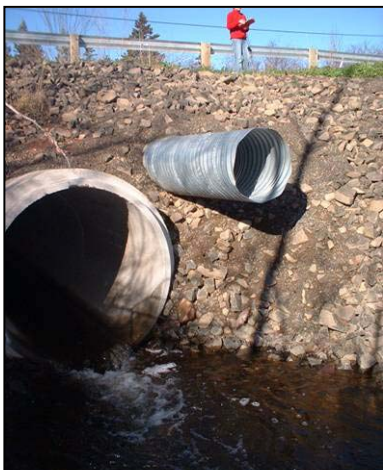
Figure 4. AC3C – Croscup Brook, downstream.

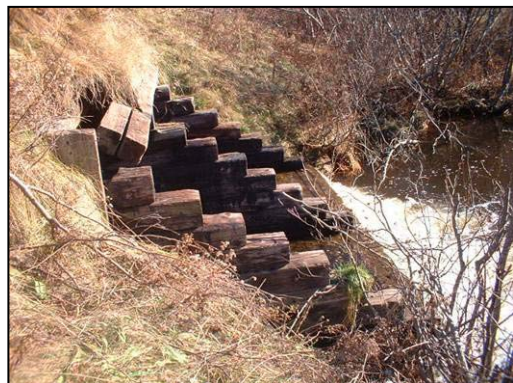
Figure 5. DC4C – Dixon Brook, downstream

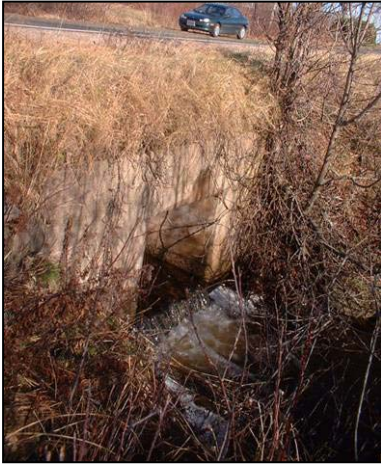
Figure 6. DC5C – Granville, downstream

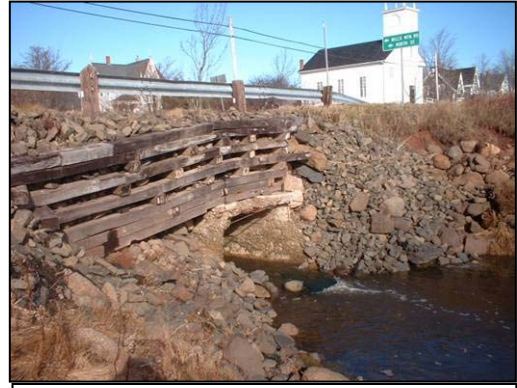
Crossing type: There are a series of culverts located along a 15km stretch of Highway 1 along the north side of the Annapolis Basin. With the exception of DC6C most of these culverts are in fair condition and made of either wood or concrete.

Figure 7. DC6C – Granville, downstream

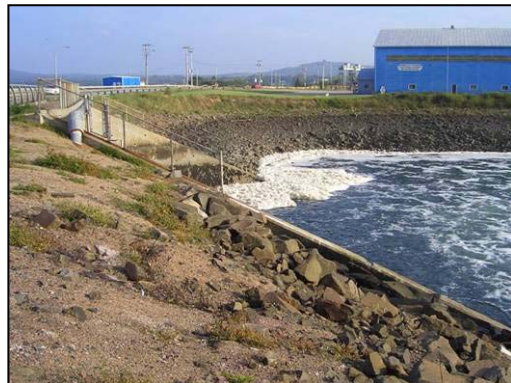
Crossing type: This causeway was constructed in 1960 to protect upstream agricultural dykelands from tidal flooding. In 1984, North America’s first successful tidal power generation station was installed in the causeway, designed with sluice gate and turbine channels (Figure 8).

Comments: Due to the purpose of this structure there is no opportunity for restoring natural tidal flow to the system at this time. There are some dyked marshes around the mouth and edges of the river as well. Installation of the tidal power generation station restored limited tidal flow and fish passage to the system. At such time as the hydro station is decommissioned, replacement of all or part of the causeway with a bridge should be considered.

Figure 8. Causeway and hydropower station at mouth of Annapolis River. Downstream end of one of the dam gates.

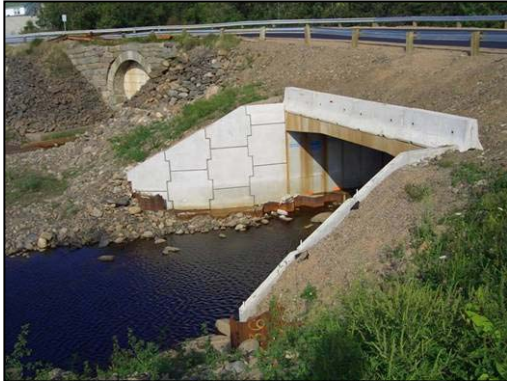
Crossing Type: Newly installed concrete culvert, second round culvert sealed off.

Comments: Since this culvert has just recently been installed there is likely little opportunity for replacement. This structure is quite large with an open bottom. Since this river is considerably larger than the culvert opening, a bridge spanning a greater portion of its width might have been the optimal crossing type. There is salt marsh downstream with a house located on the low marsh. Some salt marsh vegetation is present upstream, however, the sharp rise in elevation in a significant limiting factor. A railway crossing, further downstream, does not appear to be restrictive but was not accessible for evaluation.

Figure 9. Downstream end of the new culvert.

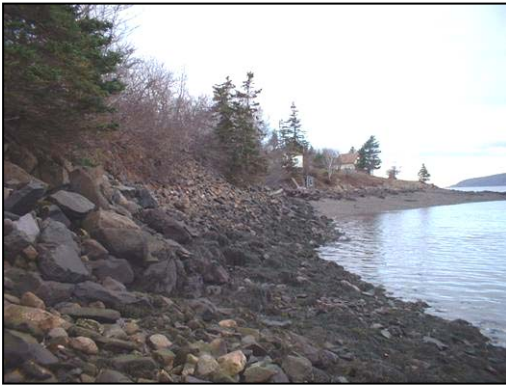
Comments: The Winchester Point culverts greatly impact the upstream wetland. The 3 culverts and resulting head pond were cleared semi-annually by railroad crews. The water seeping through the rail bed rock foundation is the only tidal water getting through to the upstream because of the complete structural failure of the culverts. This area should be cleared and repaired and most likely replaced by a more appropriately sized and placed structure in order to restore tidal flow, fish passage and increase wetland habitat. Should this occur further assessment would be needed of the Highway 1 culvert (DC7C).

Figure 10. Downstream end of rail bed; culverts completely collapsed (DC6C).

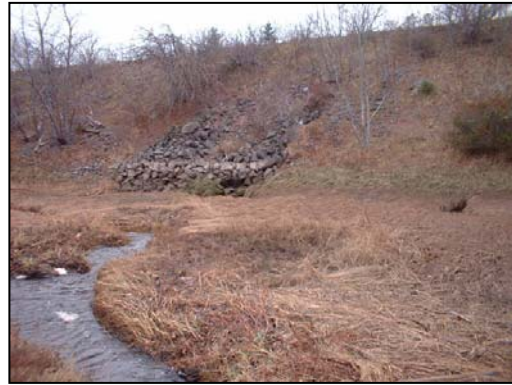
Figure 11. Upstream end of rail bed culverts, completely blocked by rock (DC6C)

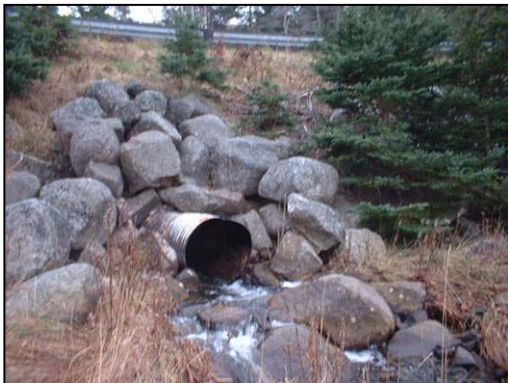
through the rocks where the structure is blocked. The Highway 1 culvert is no longer tidal and is receiving limited water flow due to the downstream blockage.

Figure 12. Downstream end of Highway 1 culvert (DC7C)

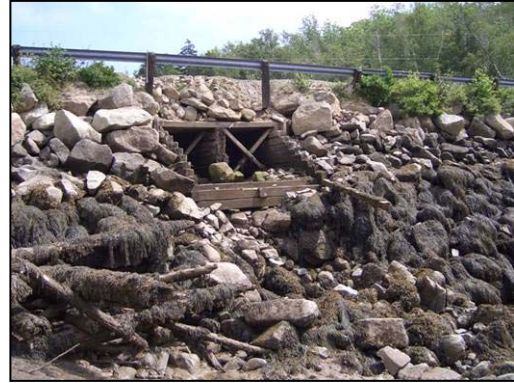
Crossing Type: This crossing contains a square wooden box culvert, 3.5 meters wide. It is filled with debris and in a considerable state of disrepair. Guardrails along the road are caving in, posing as a safety issue. The structure is also set high above the creek bed.

Comments: This culvert is too small and placed too high in the creek bed to allow for adequate flow of water and species upstream. Large boulders and debris are caving in around the crossing. There are remnants of an old wooden structure along the side of the creek just in front of the downstream end that should be removed to further improve hydrology, although these may not be causing a significant obstruction. This culvert needs to be replaced with a larger more appropriately placed structure. There is potential to improve wetland habitat conditions immediately upstream.

Figure 13. Downstream end of the culvert at low tide, filled with debris and in poor condition

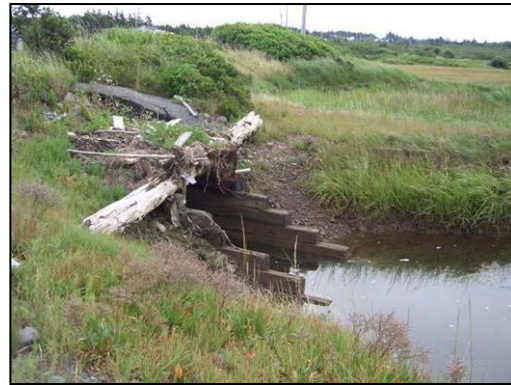
Crossing Type: This site contains a wooden box culvert, 2.5 meters wide, in poor condition and collecting debris.

Comments: Downstream of the crossing there is a large seawall through which the creek channel has been diverted before being further diverted through this culvert. There are large scour pools at either end of the culvert. Upstream is a large salt marsh system which would greatly benefit from an enlarged opening, which would also improve tidal flow and fish passage to the system. Replacement of the culvert should be considered in combination with the enlargement of the opening in the seawall. Road crossing should be similar in size to the seawall opening and more properly aligned.

Figure 14. Downstream end of culvert

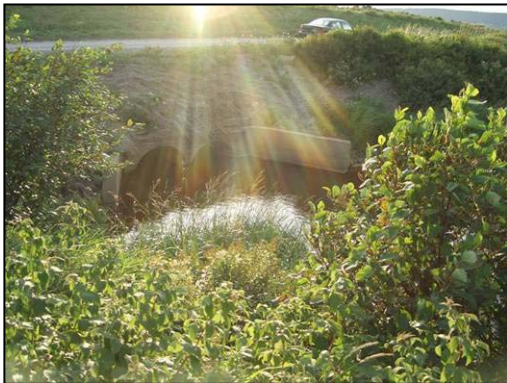
Crossing Type: This site contains two aboiteaux (upstream end: concrete/square with two round openings) within a large dyke, completely restricting tidal flow to the upstream system.

Comments: These aboiteaux are located roughly 1.5 km apart and open directly into St. Mary's Bay. Upstream is agricultural land which appears to be currently used primarily for cattle grazing. This site is of significance not only because it once was the largest salt marsh system in St. Mary's Bay, but also because of interest by one of the owners and local community in purchasing the entire dykeland area and restoring it to a functioning salt marsh. If the opportunity arises to do so, these aboiteaux could be removed (or at least the tide gates removed) and the dykes breached (naturally and/or manually), to allow tidal flooding back to the system. This would restore a large amount of converted marsh habitat back to natural conditions but is only possible if the upstream is no longer needed for agricultural purposes.

Figure 15. Upstream end of aboiteaux

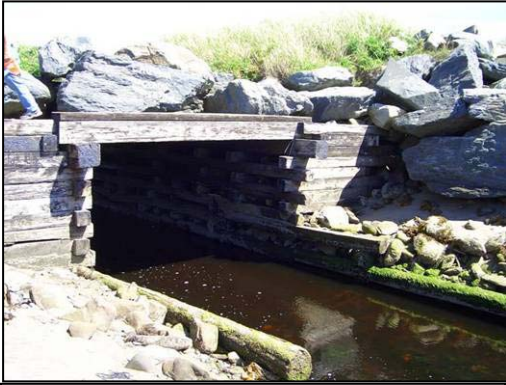
Crossing Type: The wooden bridge (DC45B) located at the mouth of the Cape St. Mary's marsh is 5m wide and opens directly onto the beach. Large boulders and wooden planks extend out around the structure and the channel. Upstream a second wooden bridge (DC44B) crosses the creek and is in need of repair. A concrete bridge that is part of Highway 1 (DC43B) crosses the creek further upstream and is significantly smaller than the channel causing the formation of scour pools and altering the path of water flow.

Comments: The Cape St. Mary's Marsh is a large system that is tidally restricted by the downstream structure at the mouth of the river. The channel has been diverted to flow through this crossing which is too small to supply adequate tidal flooding across the marsh surface and to the river and wetland system extending upstream. This should be replaced with a much larger structure placed inline with the original river path or a second larger opening installed along the roadway in inline with the original channel. The two upstream bridge structures will need to be replaced in the event of increased tidal flow from enlargement of site DC45B. Should this not occur, consideration should still be made to enlarging DC43B as it is too small an opening even under current tidal conditions.

Figure 17. DC45B – Cape St. Mary’s, downstream end.

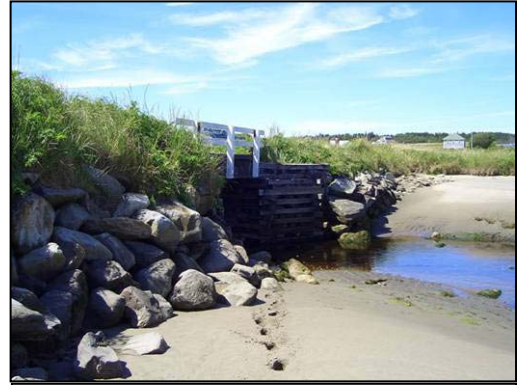
Figure 18. DC45B – Cape St. Mary’s, upstream end.

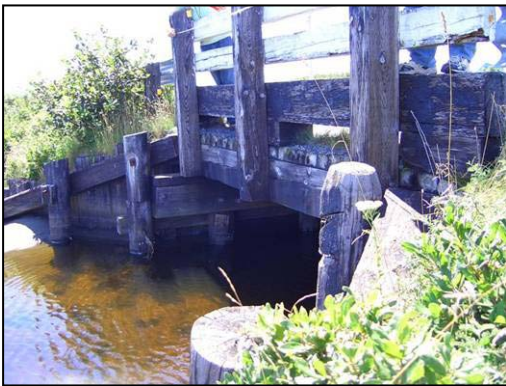
Figure 19. DC44B – Cape St. Mary’s, downstream end.

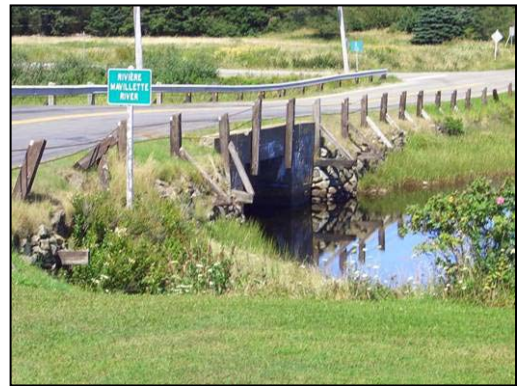
There are two additional crossings further upstream in this system (DC42B, DC41C) but these are at the upper reaches of tidal influence and not causing a large restriction to water flow under current conditions. However, if work is to be done downstream these should be reassessed.

Figure 20. DC43B – Mavillette River, upstream end.

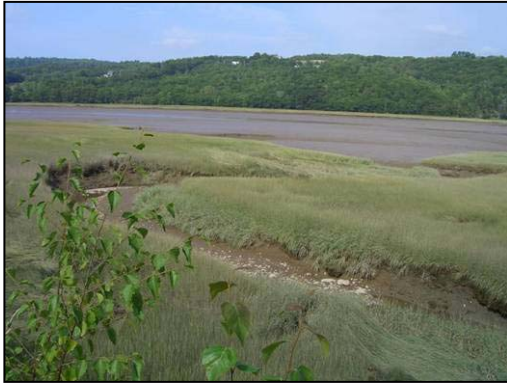
Crossing Type: Wooden box culvert in poor condition, 3.7m wide.

Comments: This is a small tributary of Bear River that leads to a small salt marsh upstream. There is not a large potential for restoration because of the sharp rise in elevation. Downstream there is fringe salt marsh running along Bear River. While there is not a huge restriction to tidal flow from this crossing when repairs are made it could be enlarged since it is causing erosion, formation of scour pools and there is a difference in stream width.

Figure 21. Downstream of crossing, Bear River system

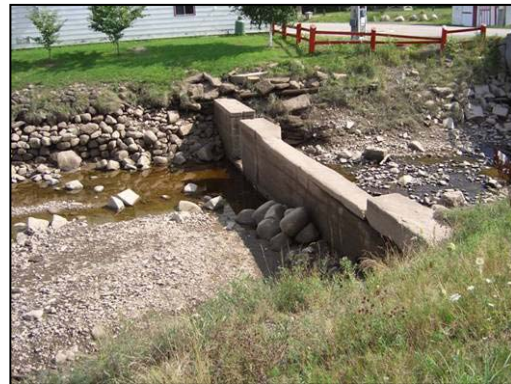
Crossing Type: The site has a 7m concrete bridge with an old dam structure just downstream. The concrete dam spans the width of the creek with a 1-2m opening.

Comments: While the bridge does not represent a restriction to tidal flow the dam opening does and should be removed if no longer serving a purpose. This site is approximately 5km inland and tidal influence may be minimal under normal tidal condition. There is no salt marsh habitat to restore, however, fish passage and water flow would be improved.

Figure 22. Downstream dam

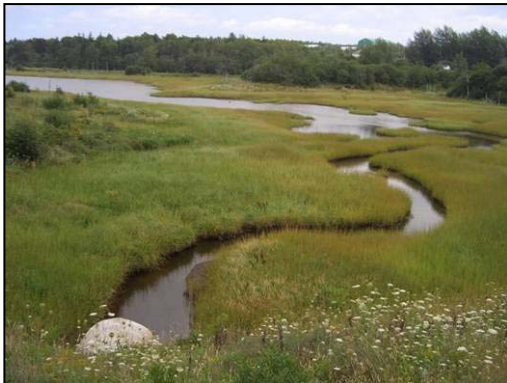
Comments: DC12C runs under the cul de sac road and Highway 303 therefore it was not possible to locate the upstream end. It appears the culvert is acting more as a draining area than it is allowing the passage of tidal water upstream. DC13C runs under the cul de sac road which opens into another small marsh before reaching Highway 303 (which also contains a small square concrete drainage culvert). There is a large salt marsh system downstream of these crossings which could be much larger and more productive if it were not for the restriction caused by the rail bed at the mouth of system.

Figure 23. Downstream view of the marsh system from DC12C.

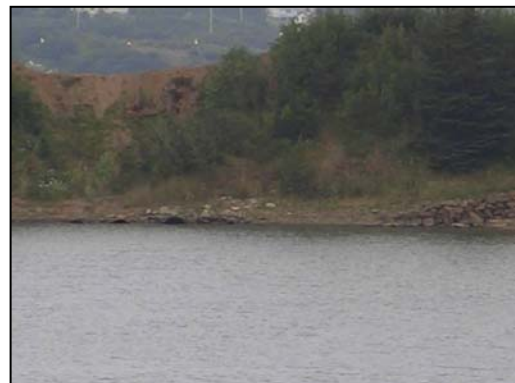
It was not possible to determine the nature of the openings under the rail bed. It was clear from the amount of water built up at the base of the rail bed that the openings are not likely to be adequate in size to allow for natural tidal flow. Assessment of the rail bed is needed to determine the options around opening the system to improve hydrology and wetland habitat. At this time upstream crossings (DC12C and DC13C), as well as the road infrastructure, will need to be reassessed to eliminate the possibility of flooding or damage should modification to the railway be considered.

Figure 24. Rail bed crossing, looking from the upstream crossings.

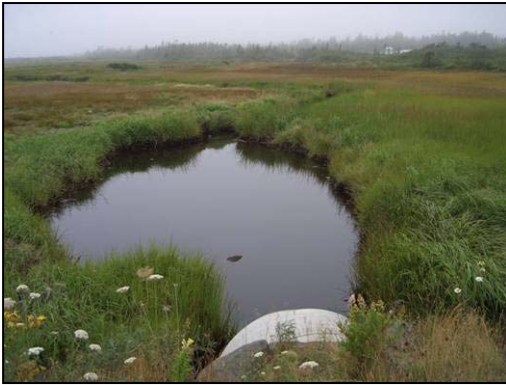
Crossing Type: Corrugated culvert 1.5m in diameter, in fair condition. Downstream end of the culvert opens on the beach and is part of a seawall, surrounded by large boulders.

Comments: There is a large scour pool at the upstream end of the culvert and a fair size marsh system. It is bordered by residential houses and an equipment storage area. Enlargement of the culvert would likely improve upstream conditions and reduce erosion (scour pool).

Figure 25. Upstream end of crossing, showing scour pool and upstream system.

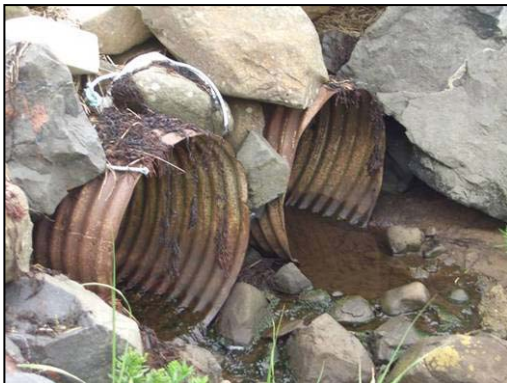
Crossing Type: Two corrugated culverts, side by side, 0.5m each in diameter, extensive rusting and collecting rock and large woody debris.

Comments: Downstream of the system is a medium sized salt marsh, while the upstream wetland is dominated by freshwater vegetation. These culverts need to be replaced since they are in poor condition. When this occurs a single larger structure should be installed to improve tidal flow upstream and increase tidal marsh habitat upstream.

Figure 26. Downstream end of the culverts, rusted and collecting debris.

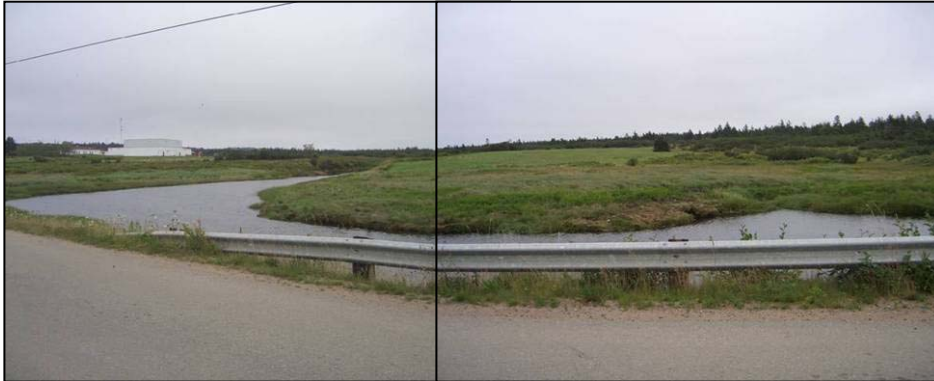
Crossing Type: Two concrete culverts side by side, 2m each in diameter.

Comments: The downstream end of this crossing opens into the ocean. Upstream the channel is diverted and flows at an angle. This system would be improved by installing a single opening, most likely a bridge since the river is quite large in size. Upstream infrastructure would have to be considered to ensure flooding does not occur.

Figure 28. Upstream system looking from on top of the culverts.

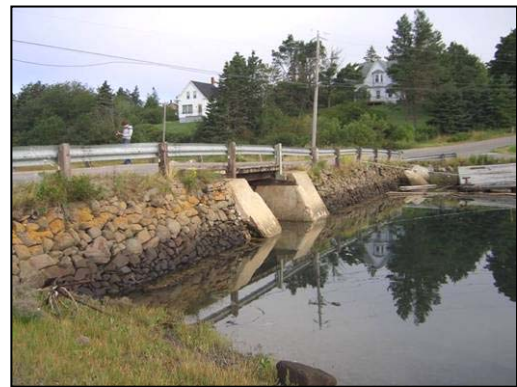
Crossing Type: Concrete bridge structure, 3.8m wide in good condition.

Comments: Since this area is being used as a wharf there may be little potential to restore this area by enlarging the opening. There is a large tidal river and marsh system upstream that could potentially benefit from an increase in natural tidal flooding. The width of the river at the upstream and downstream ends exceeds 20m. Should the opening be enlarged, upstream infrastructure would need to be assessed to determine flood risk.

Figure 29. Downstream end of crossing, much smaller than the width of the river.

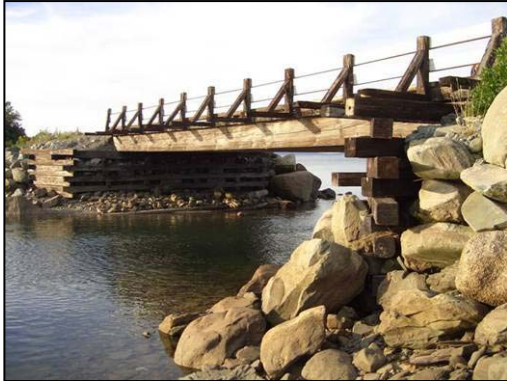
Crossing Type: Wooden bridge 18m in length

Comments: This bridge opens up onto the beach and is pinching the river slightly. Upstream there is a salt marsh system that leads to the Highway 101 bridge (DC25B). The rocks along the base of the structure could be excavated which would allow better tidal flow. This is a large bridge, however, combined with the causeway it does not span the width of the channel and is altering flow.

Figure 30. Upstream end of crossing, bridge is pinching the river channel.

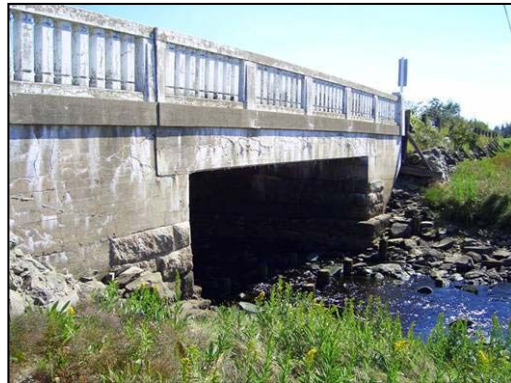
Crossing Type: A concrete bridge (DC31B) crossing at the mouth of this system with an 8.6m opening. A dirt road crosses the river further upstream and is installed with a corrugated culvert (DC32C), 0.7m in diameter.

Comments: The bridge is pinching the river causing a difference in stream widths, scour pools and bank slumping. There is a large wetland up and downstream of this crossing and enlarging the opening should be considered when repairing/replacing this bridge. Upstream a dirt road with a corrugated culvert crosses the river, further restricting tidal flow. This should be enlarged at the same time at the bridge. At the end of this road is a house whose driveway crosses the river and whose yard borders the marsh, however, this appears to be at the edge of the tidal system, with mostly forested land beyond.

Figure 31. Downstream end of DC31B, slightly pinching river channel.

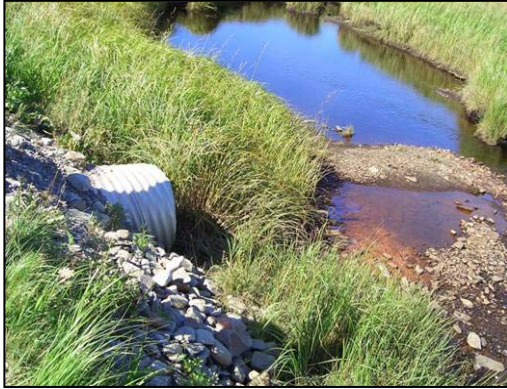
Figure 33. Downstream end of DC32C, undersized for the size of the system.

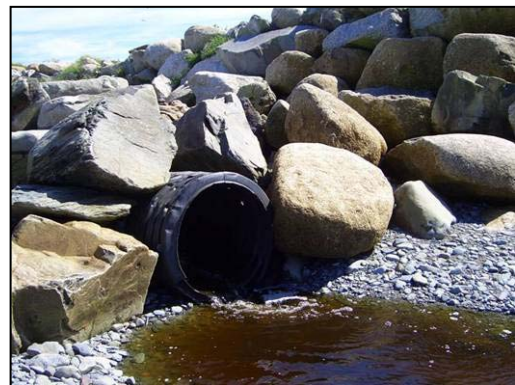
Crossing Type: The downstream end of the aboiteau extends from the dyke and opens onto the beach and is surrounded by large boulders.

Comments: The upstream system is a large freshwater marsh with a number of crossings that are no longer tidal and are not restricting water flow under current conditions. According to local residents fish passage at this site has been addressed and fish can enter the upstream system. Tidal flow could be reintroduced to the system through the removal of the tidal gates on the upstream end of the aboiteau. At that time the size and condition of the upstream crossings would need to be reassessed.

Figure 35. Downstream end of aboiteau covered by large boulders.
