## **Assessment of Tidal Restrictions Along Hants County's Highway 215: Opportunities and Recommendations for Salt Marsh Restoration**

by Tony M. Bowron and Allison Fitzpatrick

September 2001

Marine Issues Committee Special Publication Number 9  
Ecology Action Centre  
September 2001

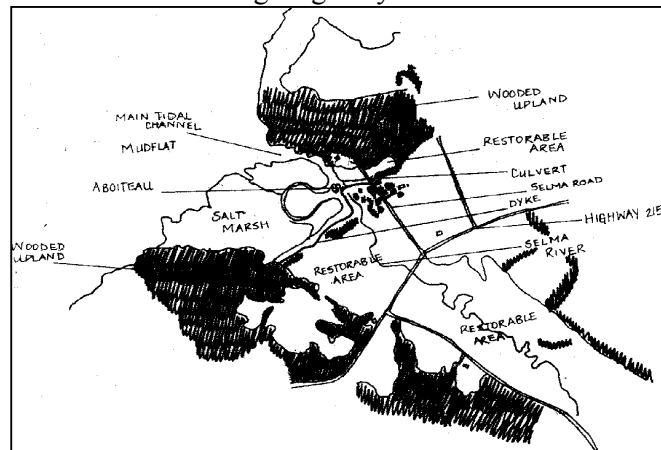
The dyke, maintained by the Department of Agriculture and Fisheries, runs for a distance of 500 metres from the unpaved road to an upland wooded area and contains a fully functional double aboiteau located where the Selma River meets the dyke. Present on the downstream end of the culvert, and seaward of the dyke is a functioning salt marsh stretching the length of the dyke and ~300m seaward.

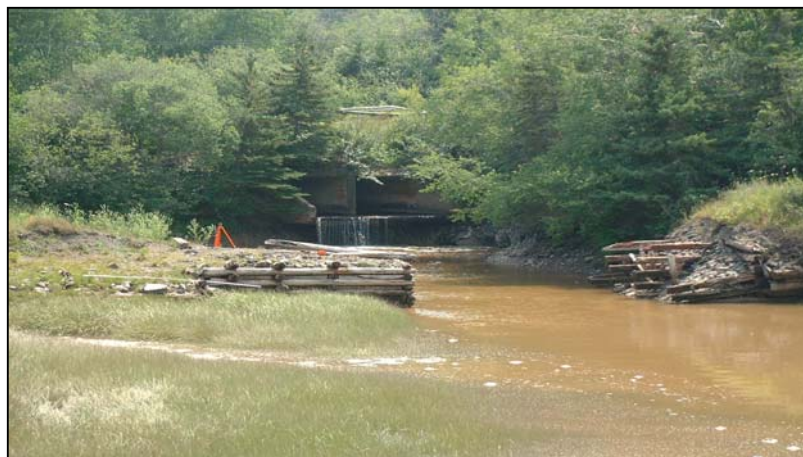
*Left: culvert at high tide (3:45pm); water just barely reaches the underside of the base of the culvert. A small amount of freshwater continues to flow out of one side of the culvert.*

Since the area upstream from Highway 215 is essentially completely restricted from saltwater flow due to the culvert location, repositioning of the culvert is necessary to remedy this problem. The culvert is on an angle with respect to the perpendicular to the road, and is situated approximately 2m above the base of the river channel. In addition to cutting off all saltwater flow upstream, pooling is occurring at the base of the culvert, leading to erosion of the banks near and beneath the culvert. The culvert size should be sufficient to allow for adequate flow, so we recommend that it be lowered until it is even with the base of the river and angled correctly with the run of the river.

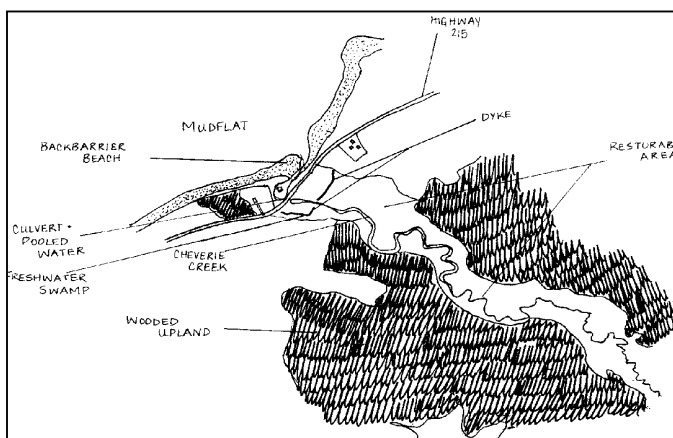
Located in the community of Cheverie, the crossing is a one and a half metre wide double wooden block culvert situated beneath a small causeway crossing Cheverie Creek. The culvert is in disrepair on both ends, most likely due to ice and other debris striking the structure. Saltwater does pass through the culvert to flood an area of approximately 4 – 5 hectares. An old dyke system is visible running parallel to the causeway; however, it does not appear to be maintained. The dyke continues to significantly influence the hydrology upstream by restricting saltwater flow to some areas and

trapping freshwater in others. From the aerial photographs, a total of 30 hectares would benefit from culvert replacement and habitat restoration work.

Downstream, water pools at the culvert with a small fringe marsh forming on the sides of the pool. A rocky, barrier beach is forming on the approach to the pool and is subsequently diverting water flowing away from the culvert downstream. Near the culvert, material from the road is sliding and being washed down the bank into the river channel.

Enlargement of the culvert is necessary to increase tidal flow upstream and to eliminate the lag between the upstream and downstream ends. Placement of the culvert is also of concern as the barrier beach that is forming may eventually cut off all flow to the culvert and cause water to flood the road. We are aware that the causeway is a popular stopping spot for tourists as it faces Cape Blomidon so replacement of the entire causeway with a bridge is not a viable solution. The replacement of the existing culvert with a larger culvert, or even a small bridge, would increase tidal flow significantly, reduce the dangerous currents and would not require replacement of the entire causeway. Removal of the dykes in place, which do not appear to have any agricultural function, would also allow saltwater to flow more fully over the original marsh surface and eliminate the freshwater flooding that currently occurs in the area.
